“Haggie Hints”

Issue 4, 2002

The Effects of a Tight Groove in a Headsheave (Including Plastic Inserts)

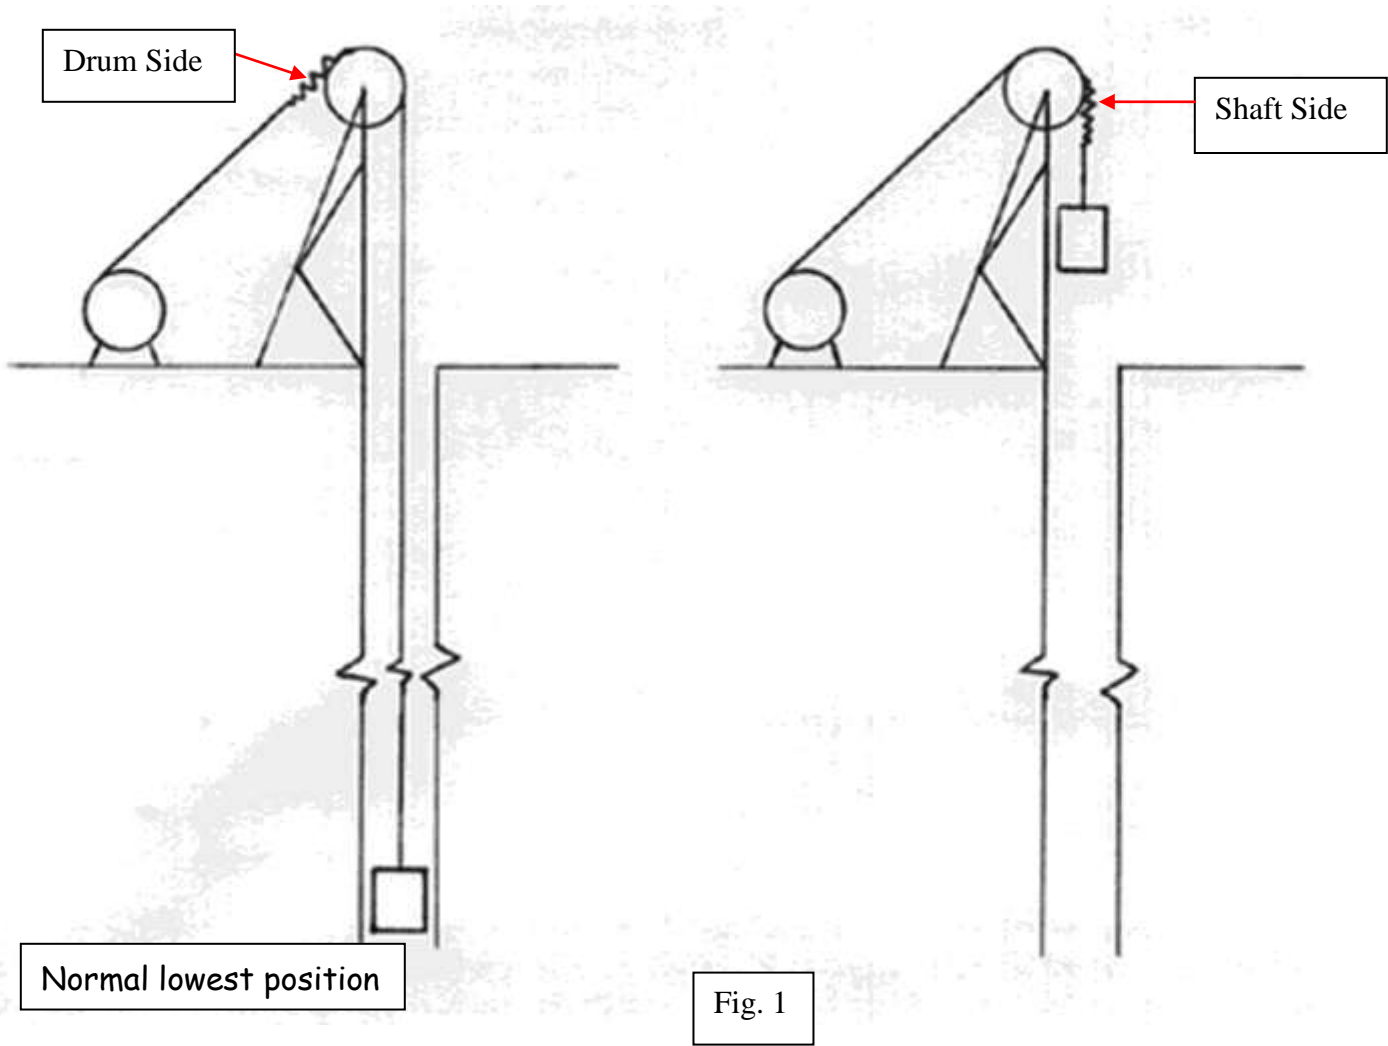
As the new rope enters the sheave groove as the conveyance descends (and it normally does so with no payload and thus the rope is in a relaxed condition), it is very easy for the un-bedded rope to have the strands displaced over the core. To further complicate the issue, for at least some of the time, the rope is entering the sheave at the maximum fleet angle that makes the groove appear even smaller. This strand displacement will continue until the descending conveyance stops; usually at the load position. The following sketches (Fig. 1,2 & 3) show where this accumulation gathers and the resultant upset is usually described as a "Wave" or "corkscrew".

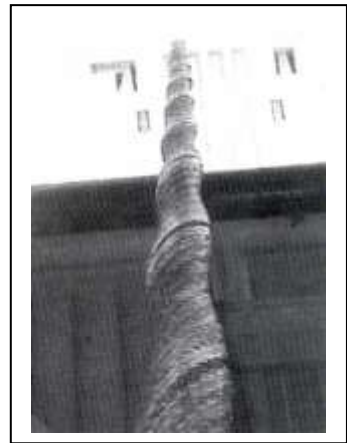
Fig. 3 - Another example of a "wave" positioned at and viewed from the hoistroom

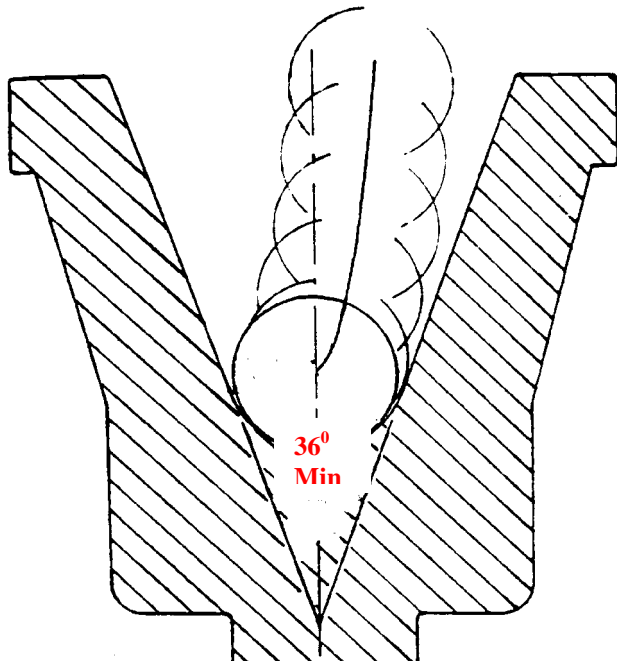
In Addition to the 10% diameter clearance, the sides of the grooves must also allow the rope to enter without contact. The following sketch (Fig. 5) shows the path the rope takes when entering a headsheave when the sheave to rope ratio is 80:1 and the fleet angle is $1^{\circ} 20'$ and in order to avoid contact, a 36° included angle must be available. If the sheave to rope ratio is 100:1, then the angle must be increased to 45° .

Fig. 5 - Rope path entering a groove @ 1°20' and sheave to rope ratio of 80:1

It is also recommended that the sheaves at least be aligned towards the middle of the drum or more accurately towards the middle of the active rope wraps to ensure that unnecessary contact is minimized between the rope and the side of the sheave liners.
