“Haggie Hints”

Issue 13, 2012

Koepe Balance Ropes - the care and maintenance of the conventional wire rope designs.

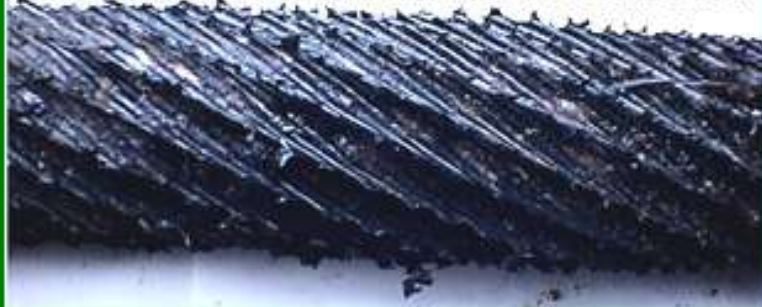
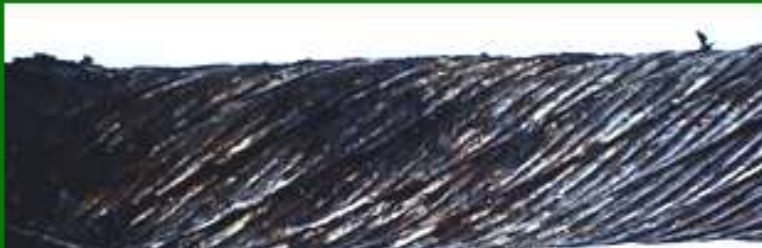
THIS PHOTO SHOWS THE PLASTIC IMPREGNATION OF THE SECOND LAYER

Plastic stripped off - Minimal Nicking

Fig. 5 shows the minimal amount of cross-cutting within such a rope after it had been in service for 2-1/2 years working in a corrosive environment. It should be noted that the elimination of heavy wire nicking ensures that the results of the EM testing are considerably more accurate.
